# Conservation in Archaeology: Case Studies in the Mediterranean Region

Roberto Nardi

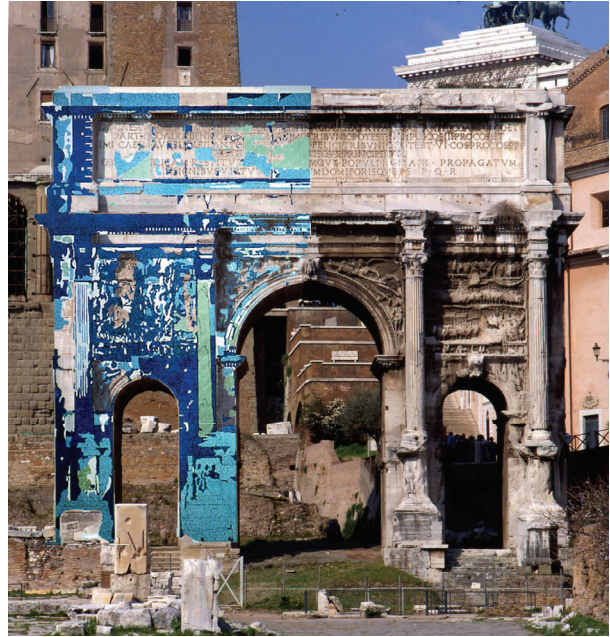
**Figure 1.** The arch of Septimius Severus in the Roman Forum was documented using scaled maps to make logical clusters of the numerous features noted on the surfaces. This is the map of the superficial deterioration mechanisms (1980).

The problem was resolved thanks to the use of typical archaeological techniques: graphic surveys in 1:20

and 1:5 scale and technical analysis of the surface. Once the monument had been drawn by hand, the vertical stratigraphy was studied and thematic maps were produced to make logical clusters of the numerous features noted on the surfaces. First steps were also made in the use of computer graphics, a field that looked promising but was still young.

Apart from giving us a topographical record of all the treatments we performed during the conservation intervention, the archaeological surveys and maps immediately made the monument's vast size more manageable and allowed us to identify some connections

between the decay and the condition of the monument. For example, the missing cornices changed the original rainwater disposal system and this could be linked to the type of decay of the surfaces below. This observation had an immediate impact on planning for the restoration of the top part of the arch.

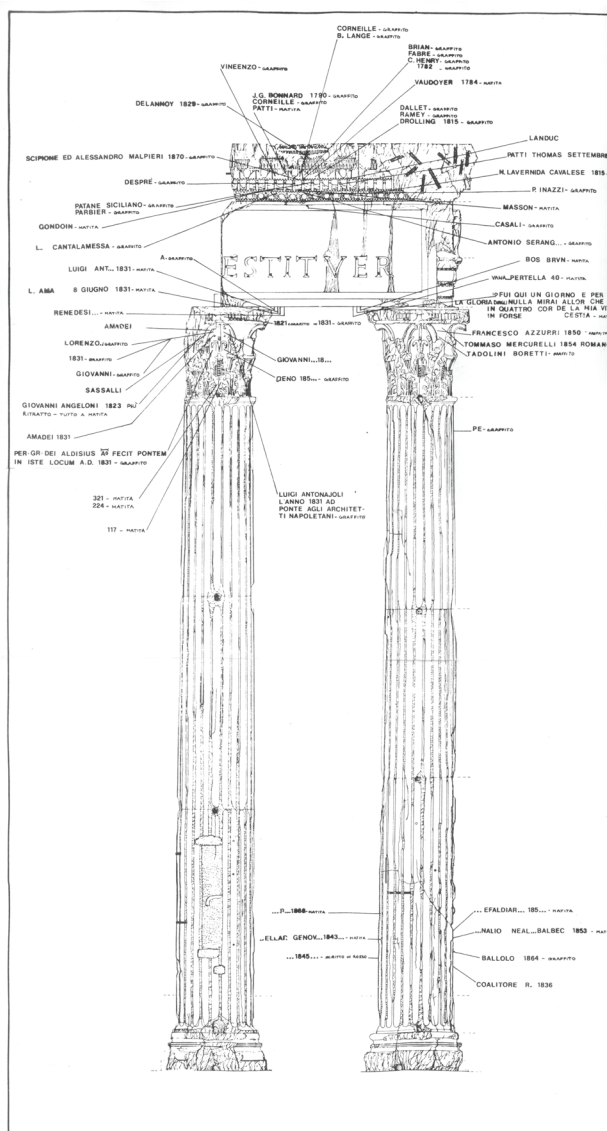
**Figure 2.** The temple of Vespasian in the Roman Forum. The study of surfaces revealed stratified signs that speak of ancient maintenance, usage, illustrious visitors, burial, and abandonment (1985).

The arch of Septimius Severus in the Roman Forum reminded us of the modifications and structural integrations done at the Temple of Vespasian. Perhaps the most significant factor in understanding the monument and making operational decisions was documentation of the so-called “*scialbature*.” These are layers of calcium oxalate found beneath the black crusts of deterioration. They are a micron thick, monochromatic, and range in color from light beige to brown or red ochre. One can find stratified signs on them that speak of ancient maintenance, usage, illustrious visitors, burial, and abandonment. This is the monument’s historical stratigraphy.

In earlier years, these layers were considered to be dirt and thus were sandblasted and removed. To us, they not only revealed a fascinating part of the history of the building, but also gave us fundamental indications on the ancient practice for maintaining monuments and the use of lime as the basic material for the current restorations. Starting from these observations, we could develop and reintroduce the use of lime for mixing mortars and stuccoes for repairs, consolidation, surface protection, and maintenance.

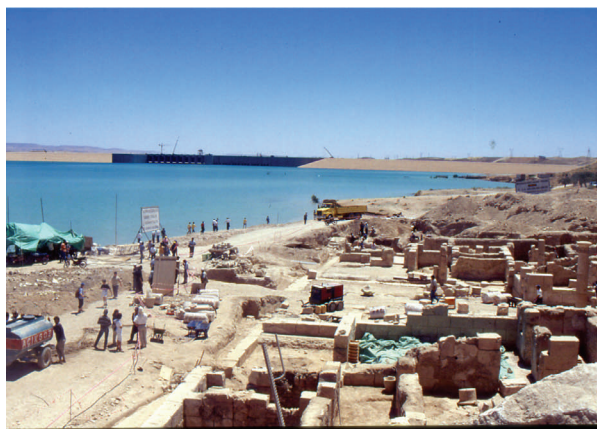
**Figure 3.** Zeugma, Turkey. Some 30 percent of the Roman city was going to be submerged in 2000 by a lake generated by a dike on the Euphrates. Thanks to the Zeugma Conservation Program, (ZAP2000), funded by the Packard Humanities Institute (PHI), California, this section of the site was investigated and reburied before the flooding (2000).

The Zeugma conservation program, ZAP2000, was implemented thanks to funding by the Packard Humanities Institute (PHI) in California. In 2000 a dike was built on the Euphrates River causing the formation of a lake at Zeugma that submerged some 30 percent of the Roman city. Before this happened—and before the phenomenon came under the control of the ZAP2000 project—the site had been the object of archaeological investigations that led to systematic detachment of all the mosaics. There was no selection, no professional conservators, and no documentation. The result was a heap of mosaics cut into pieces, glued to canvas or on cement, piled haphazardly outdoors in a museum garden or in storage, without proper excavation references or numbering.

The ZAP2000 Project implemented new conservation treatment begun in 2000; piece by piece documentation permitted us to recompose the pavements individually and continue on to restoration. This operation, which lasted three years, produced 50 pavements, equivalent to more than 1,000 square meters; among which are some figured polychrome mosaics that now are part of the extraordinary collection of Turkey's Gaziantep Museum. From a technical conservation standpoint, study of the original mortars gave us the information needed to reproduce new setting beds for the tiles. The conservators produced these new beds based on original techniques with the conviction that only such an approach could give the mosaic some of the stability it had lost when detached from its original location.

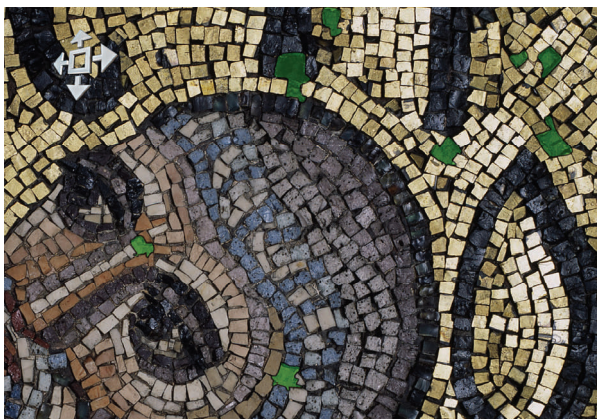
**Figure 5.** Mosaic of the Transfiguration. The Apse, Peter. Thanks to the high resolution documentation, albeit not losing sight of the overall picture, it was possible to characterize every single tile—for example in the case of the 1547 restoration work, in green in the picture (2007).

of the Monastery of St. Catherine's in the Sinai, we relied on high-resolution digital photography and image-processing software that can now be used even on scaffolding. A system was developed to record and manage the data at a scale of 1:1. Given this facility we could highlight and characterize every single tile without losing sight of the overall picture (for example, in places where one tile was missing or had been replaced). Conservation of the mosaic was made possible thanks to funding by the Emir of Qatar, Sheik Hamad bin Khalifa Al Thani, and the Getty Foundation.

Among other things, this option allowed us to adopt a solution for integrating the mosaic that we would have hotly contested only a few years ago: the use of new tiles to fill the gaps. Study of the mosaic's working techniques had supplied—again in this case—the indications for identifying the materials and proportions to use to consolidate the crumbling and detached preparatory layers. Yet even in this case there were interesting surprises, such as the use of color to prepare the underlying drawing. The paint, showing through interstices between the tiles, fills and completes the chromatic effect of the mosaic and intensifies the transmission of light by the glass and gold tiles. A treatment aimed at conserving the mosaic's iconographic message, luminosity, and theological function could not ignore these important aspects of the original working technique. Indeed, it was inspired by them.

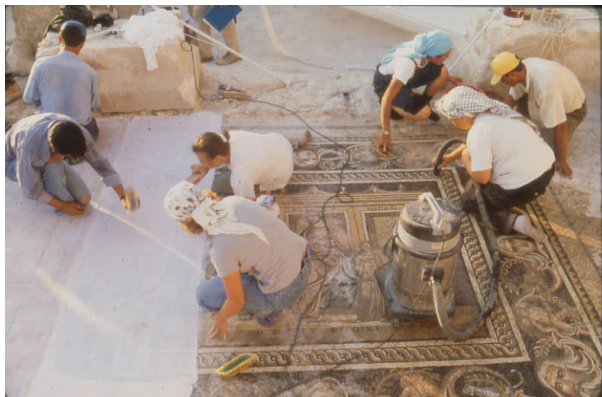
**Figures 6.** Zeugma—Conservators at work on site implementing preventive conservation activities trying to anticipate the flooding.

precise methodological lines (designed with David Packard and Richard Hodges, and approved by the Minister of Culture of Turkey). First among these was to plan the archaeological investigation using the entire area expected to be submerged as reference scale and the level of the water's rise as the timeline (implemented by the Museum of Gaziantep and Oxford Unit). Second was to affirm that conservation *in situ* was the optimum choice for maintaining the archaeological structures. We introduced, on the one hand, a criterion for choosing what to remove and what to leave (naturally all the movable objects and a selection of facings to be detached), and, on the other hand, we organized large-scale operations of consolidation and protection for sending the site under water with the least damage to the archaeological structures.

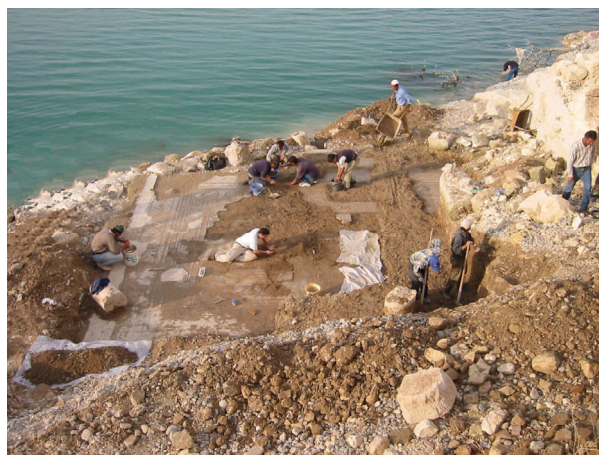
**Figures 7.** Zeugma—Conservators at work on site implementing preventive conservation activities trying to anticipate the flooding.

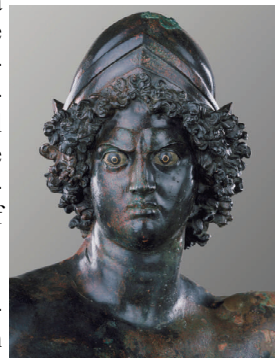
**Figure 8.** The bronze statue of Mars at Zeugma after the conservation treatment (2003).

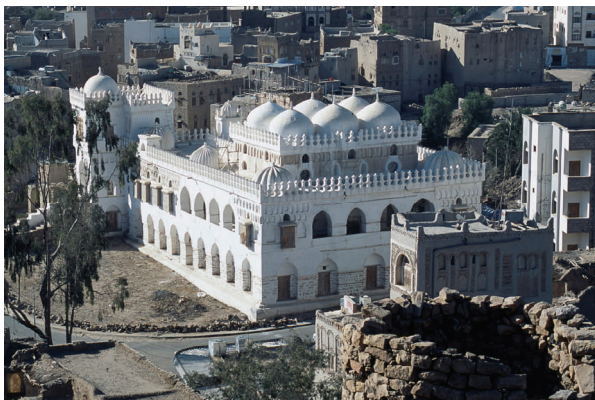
**Figure 9.** Amiriya Madrasa. General view of the complex, once the conservation program was completed (2005).

There is also the case of the Amiriya Madrasa in Yemen (2003–2005). There, the conservation project, funded by the governments of Yemen and the Netherlands, was the occasion for training a group of six local operators from the Yemeni General Organization for Antiquities, Museums, and Manuscripts. Following the training course, they would take up responsibility for maintaining the monument. The training course in wall painting conservation was funded by the Italian Ministry of Foreign Affairs and in 2007, Selma Al Radi, director of the Amiriya Madrasa Conservation Project received the Aga Khan Award for Architecture.

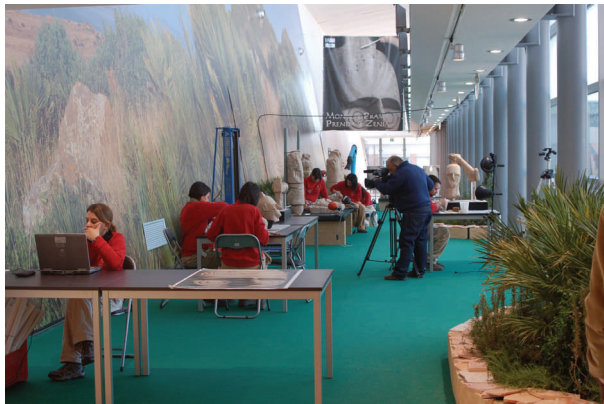
**Figure 13.** Sassari, Italy. The worksite for the conservation of the nuragic sculptures of Monteprema was planned bearing in mind the need to give maximum emphasis to public information: a special laboratory was designed for circulation of visitors and information.

Another case of public outreach is that of the conservation and restoration of the nuragic statues of Monteprama, in Sardinia. There, the worksite was planned bearing in mind the need to give maximum emphasis to public information: a special laboratory was designed for visitor circulation and information exchange. For the first time, a professional press agent joined the staff of conservators. Direct contact with visitors was established through a web page and many visitors returned frequently ([www.monteprama.it](http://www.monteprama.it)). Among other things, the page allowed us to follow public opinion regarding the conservation program. This press operation proved to be a great success: not

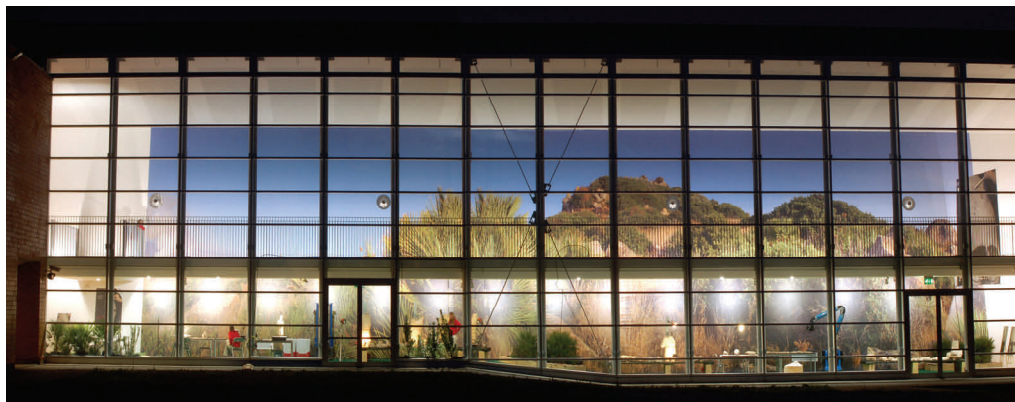
**Figure 14.** Sassari, Italy. The conservation of the nuragic sculptures of Monteprema. A special laboratory was designed for circulation of visitors and information exchange.
